PRIMARY HEALTH CARE CENTERS
NUMBERED KE-01, KE-02,
KE-03, KE-04, AND KE-05
KIRKUK, IRAQ

SIGIR PA-06-042
SIGIR PA-06-043
SIGIR PA-06-044
SIGIR PA-06-045
SIGIR PA-06-046

APRIL 25, 2006

SUBJECT: Report on Project Assessments of Primary Health Care Centers Numbered
KE-01, KE-02, KE-03, KE-04, and KE-05 in Kirkuk, Iraq (Report Numbers
SIGIR-PA-06-042, PA-06-043, PA-06-044, PA-06-045, and PA-06-046)

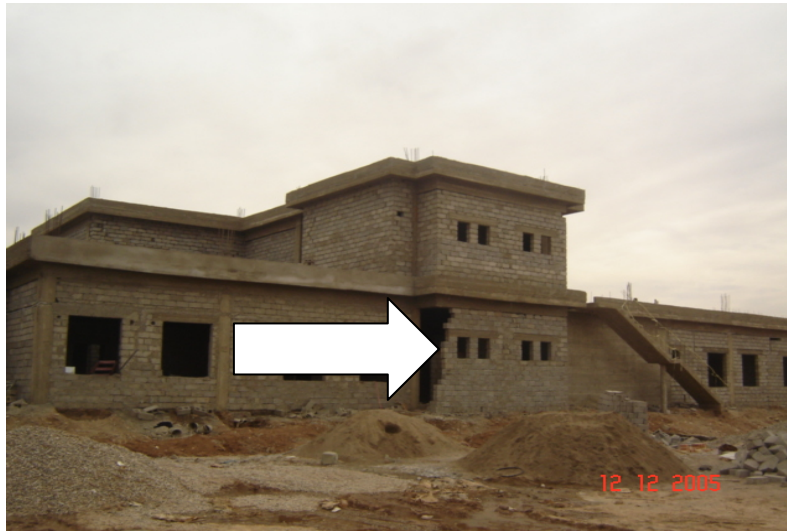
Site Photo 18. View of Hai Alhajjaj on 12 December 2005. According to the PCO construction database, this PHC was 56% complete (Photo courtesy of the USACE)

Based upon Parsons' completion spreadsheet, the PCO construction database, and RMS' completion percentages of 56% and 58%, respectively, for the Hai Alhajjaj PHC (Site Photo 18) appears to be high, considering that the block walls, roofing, utilities and interior finishing work were not complete.

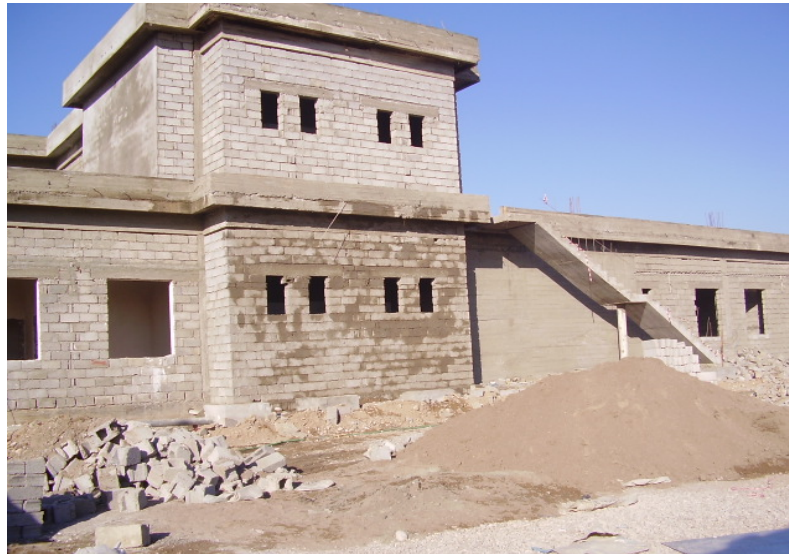
Site Photo 19. View of Shiqaq Hai Musalla on 10 December 2005. According to the PCO construction database, this PHC was 56% complete (Photo courtesy of the USACE)

Based upon Parsons' spreadsheet, the PCO's construction database completion percentage of 56% appears to be high for the Shiqaq Hai Musalla PHC (Site Photo 19). From the available photo and information, the concrete work appears to be completed, which according to Parsons' spreadsheet, puts the PHC at approximately 50% complete.

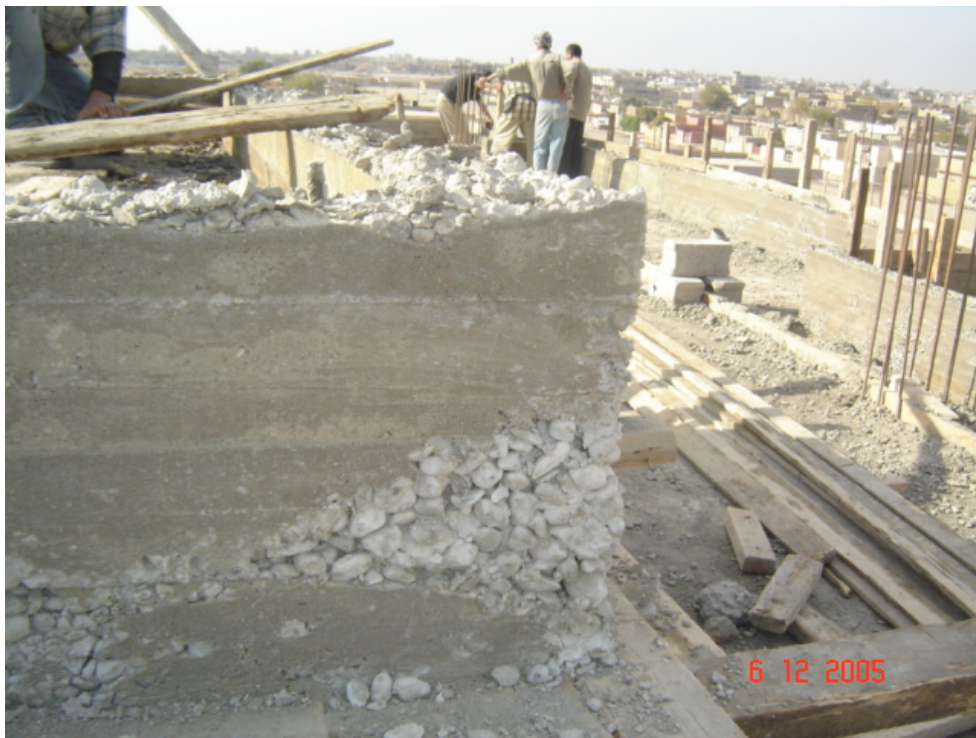
The Gulf Region Division's comments state that, "Poor concrete work has been a significant problem with the PHC contractor's work." However, we found only one instance where the USACE LN QA engineer documented the occurrence of this problem out of all five clinic projects. The LN QA engineer for the Hai Alhajjaj PHC provided Site Photo 25 with his daily QA report. The daily QA report stated, "there is segregation appears in the poured parapet." According to the daily QA report, the LN QA engineer answered the question about any verbal instructions given to the contractor with "NO." We reviewed the daily QC reports and there is no mention of any concrete issues raised by the LN QA engineer. In addition, the segregation issue was not listed in the required deficiency log. Therefore, even though the LN QA engineer identified and documented poor concrete workmanship, he did not point the issue out to the contractor. Since the USACE project engineer reviewed the daily QA reports, he should have followed up with the contractor and the LN QA engineer to determine the issues were adequately addressed and corrected.

Site Photo 25. Extensive segregation of concrete in the parapet

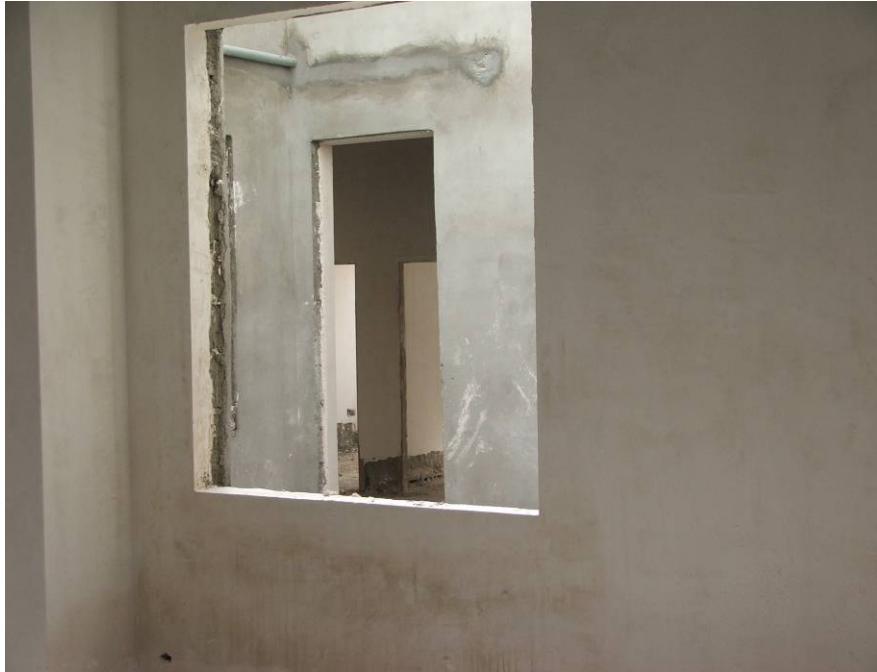
The contractor had neither completed the installation of window frames nor installed any windows or security grilles (Site Photo 49). We observed the beginning of tile installation (Site Photo 50). Interior walls had not been painted and fabrication of the suspended ceiling had not started. We did not observe any doors, window, or hardware on site.

Site Photo 49. Window opening without window frame

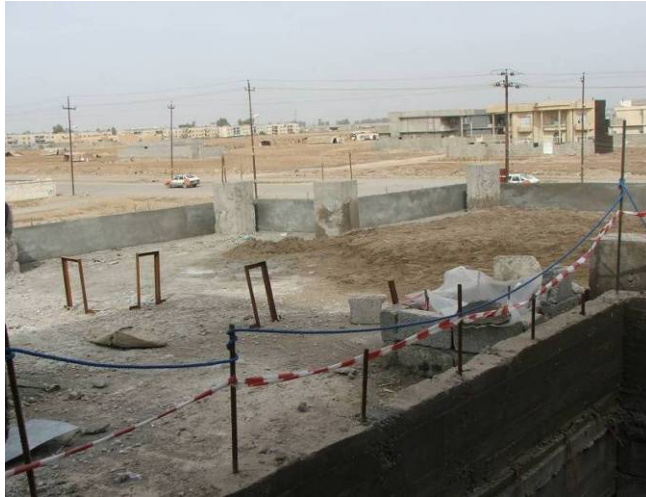
Site Photo 66. Roof in need of cleanup prior to tarring

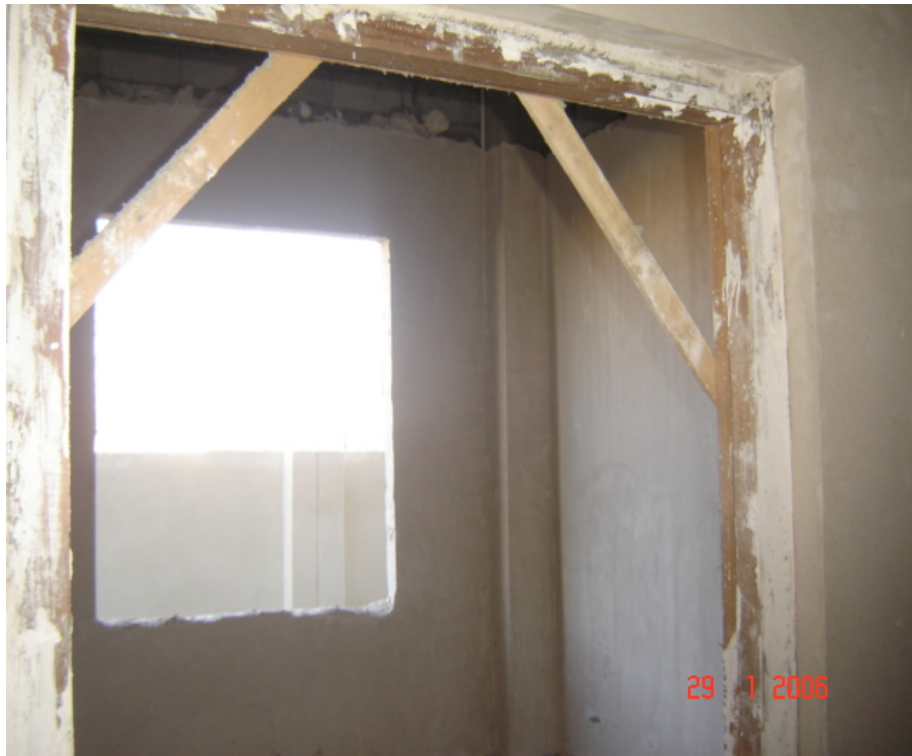
**Site Photo 74. Example of window without window frame and grilles
(Photo courtesy of the USACE)**

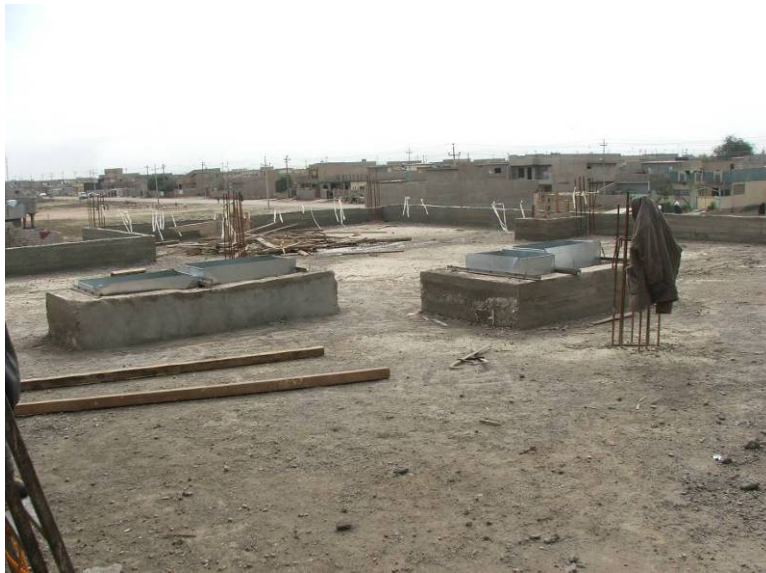
Site Photo 80. Condition of the roof

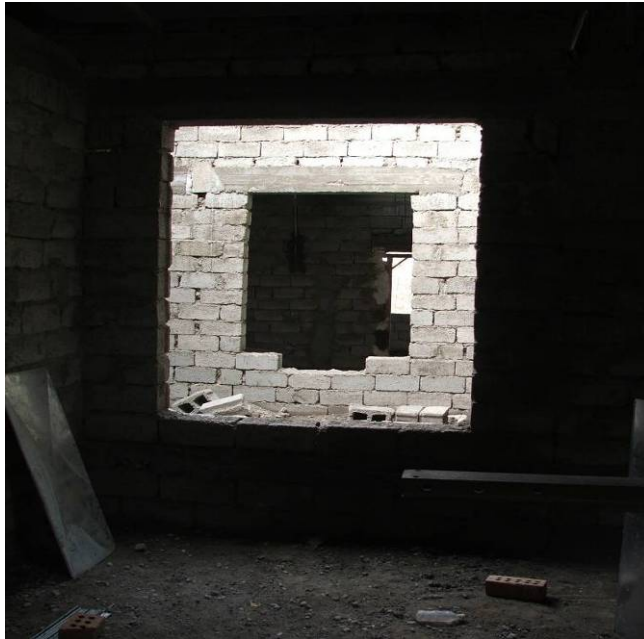
Site Photo 86. Windows without frames
